INVESTIGATION OF ENGINE PERFORMANCE AND HIGH-TEMPERATURE

PROPERTIES OF PRECISION-CAST TURBINE BLADES

OF HIGH-CARBON STELLITE 21 AND

CONTROLLED-GRAIN-SIZE STELLITE 21

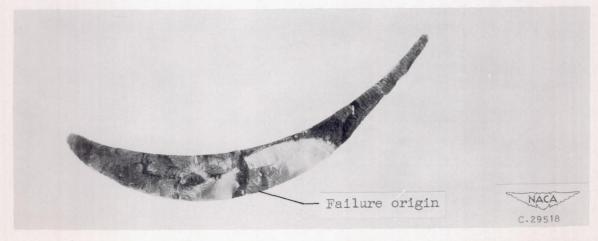
- (3) In the failures of figure 9(c), the fracture originated in a zone similar to that described for the stress-rupture-type failure, and then progressed through a zone of the fatigue-type failure. The stress-rupture origin of these failures is determined by macroscopic and microscopic examination of both the initial cracks detected during operation and the final fracture. These failures will be classed as the stress-rupture-followed-by-fatigue type.

(c) Stress rupture followed by fatigue.
